May 2, 2013

RE: Letter Report
Pre-demolition Asbestos Inspection
Bearmouth Rest Areas, Drummond, Montana
Northern Project Number 149-057

TABLE 1
SUMMARY OF MATERIALS SUSPECTED TO CONTAIN ASBESTOS
Bearmouth Rest Areas
Drummond, Montana
Northern Project Number 149-057

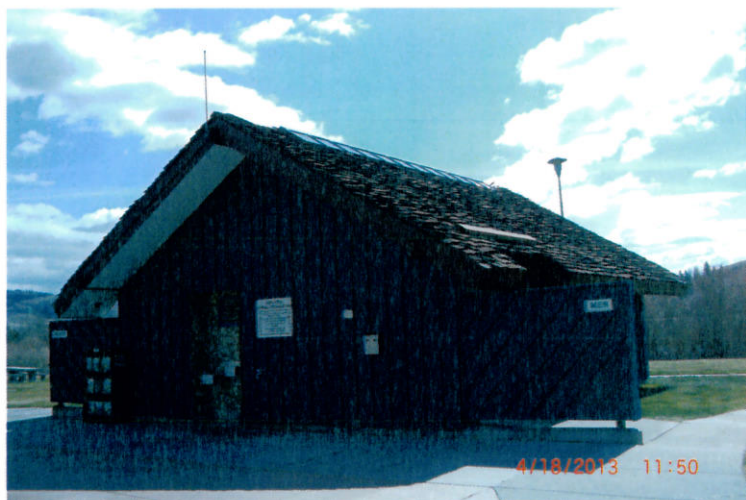
Photograph 1
Bearmouth West Bound Rest Area Exterior.

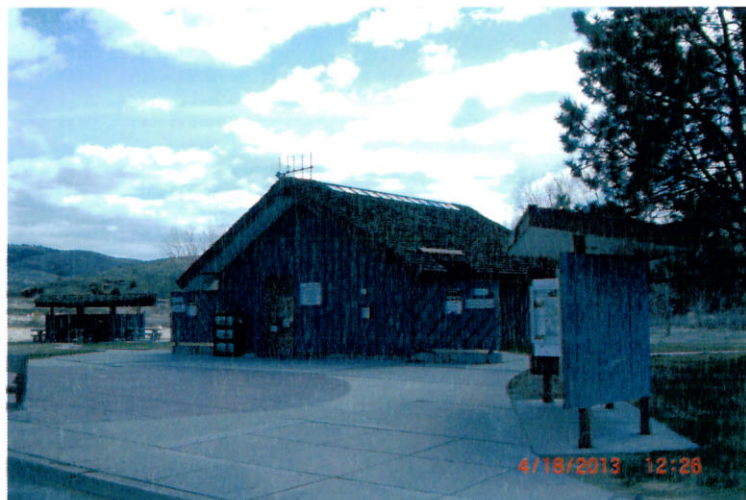
Photograph 2
Bearmouth East Bound Rest Area Exterior.

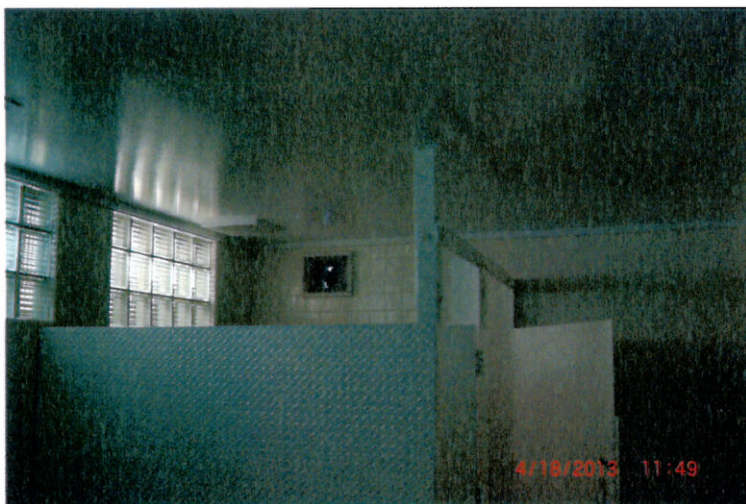
Photograph 3
Interior Men's Rest Room Walls and Ceilings.

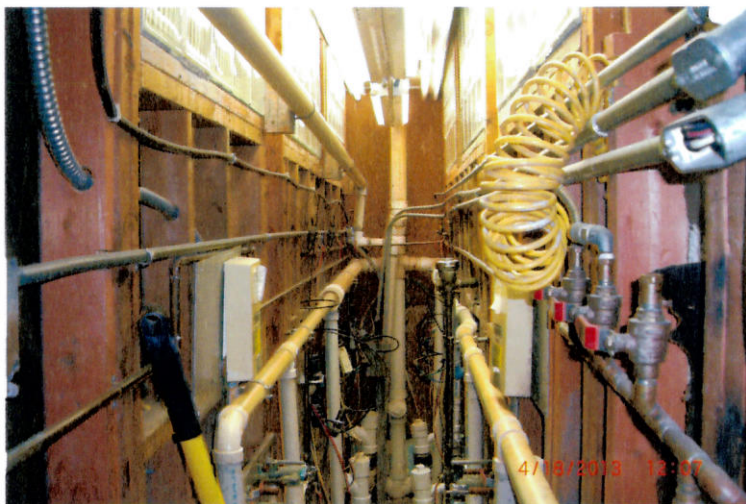
Photograph 4
Mechanical Room Electrical / Plumbing Chase between Men's /
Women's Rest Rooms.

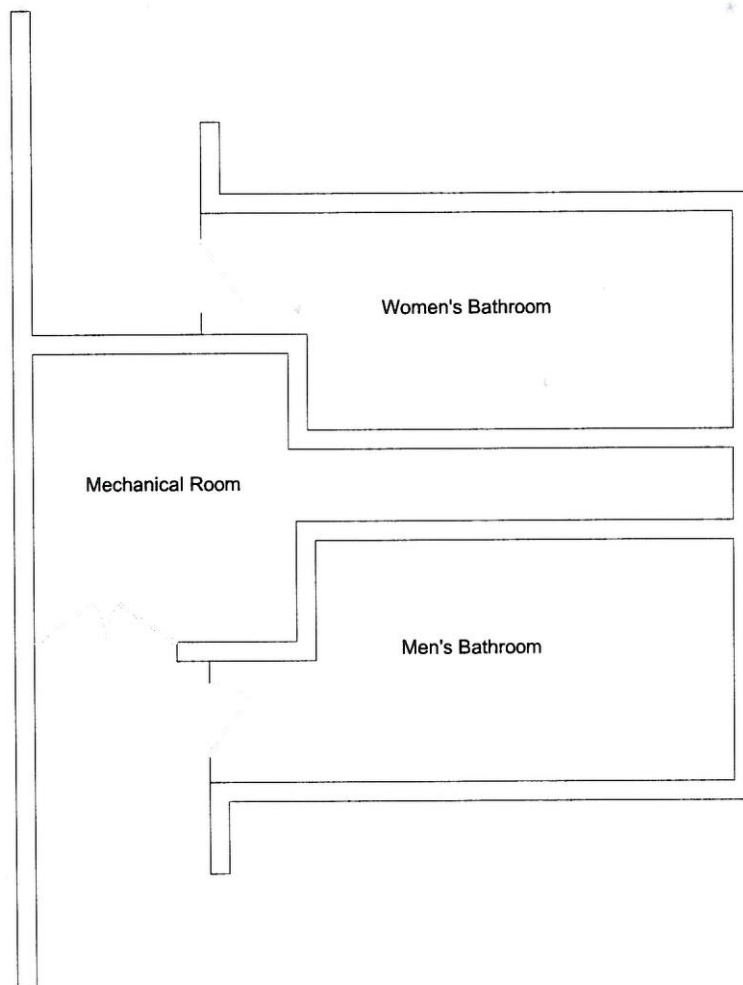
FIG 1 - NORTH AND
SOUTH BOUND REST
AREAS ACM PLAN

NO ASBESTOS CONTAINING MATERIAL IDENTIFIED
